Borough Of
Swissvale
Established in 1898.
Swissvale, Pa 15218

Borough of Swissvale –Municipal Building Study
EXISTING FACILITY EVALUATION REPORT

SWISSVALE MUNICIPAL BUILDING – Existing Conditions Report

7560 Roslyn Street
Swissvale, PA 15218

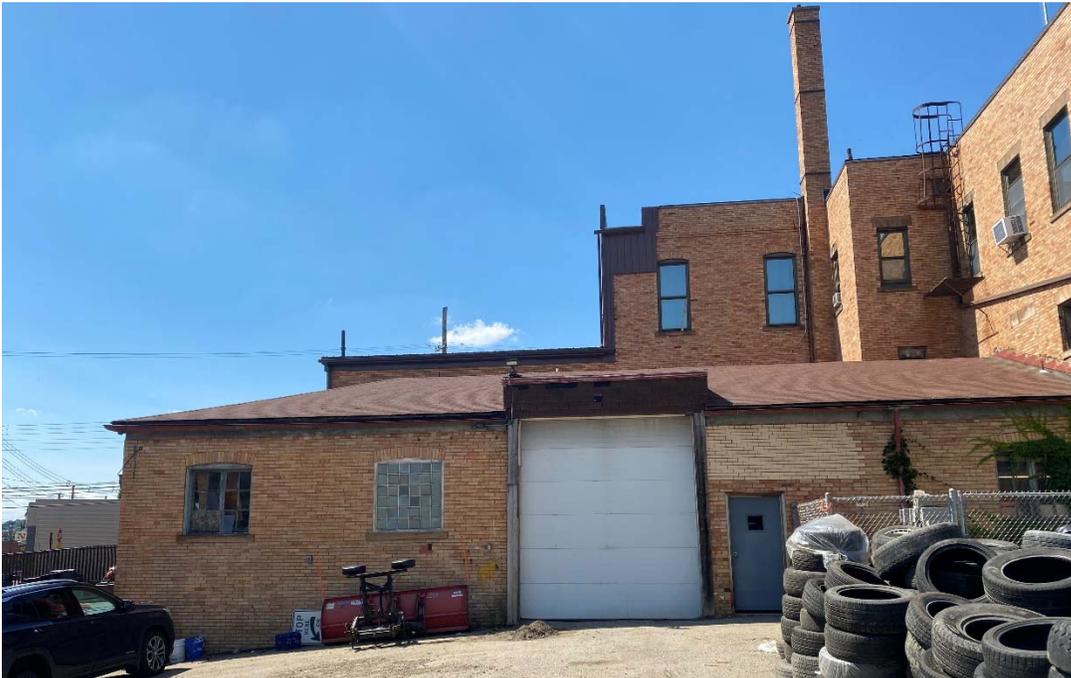
6 – MAINTENANCE GARAGE

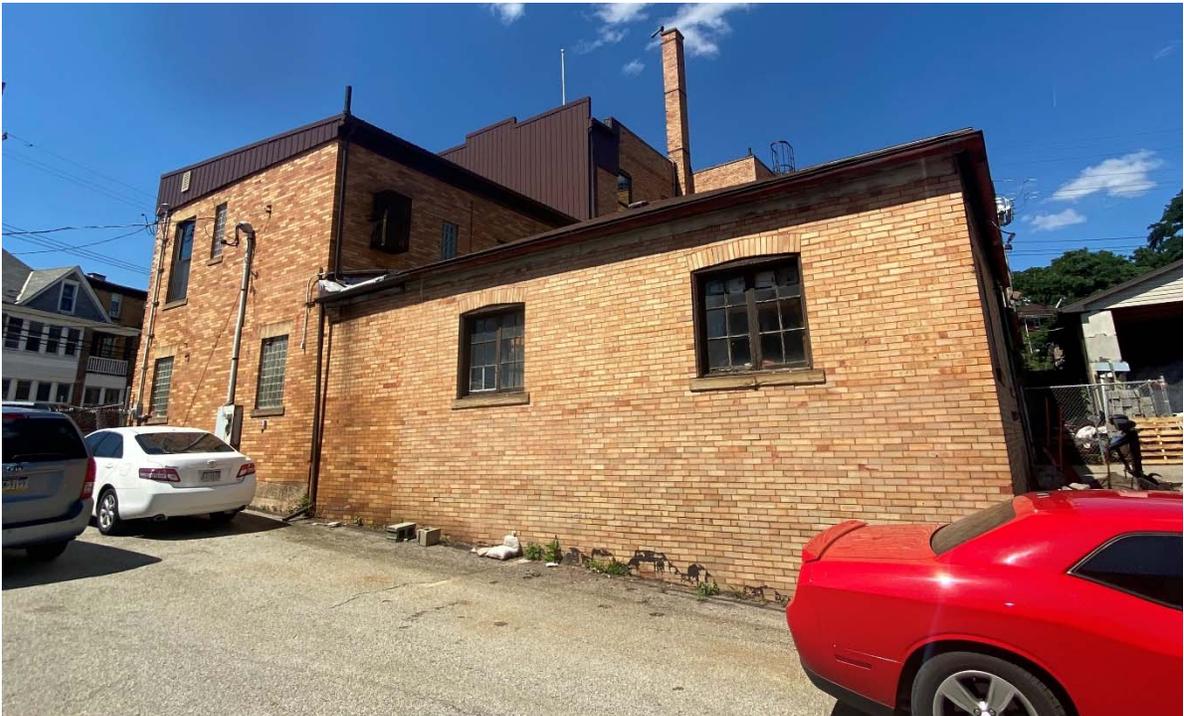
- The brick veneer is in poor condition; there are signs of deterioration and compromise of the weathering and thermal envelope; including mortar cracking, disintegration, and water infiltration.

- The brick veneer at the 1906 building is not properly tied back to the masonry backup construction. It is observed that many parts of the veneer are bulging and/or out of plane.

8 – TYPICAL EXTERIOR

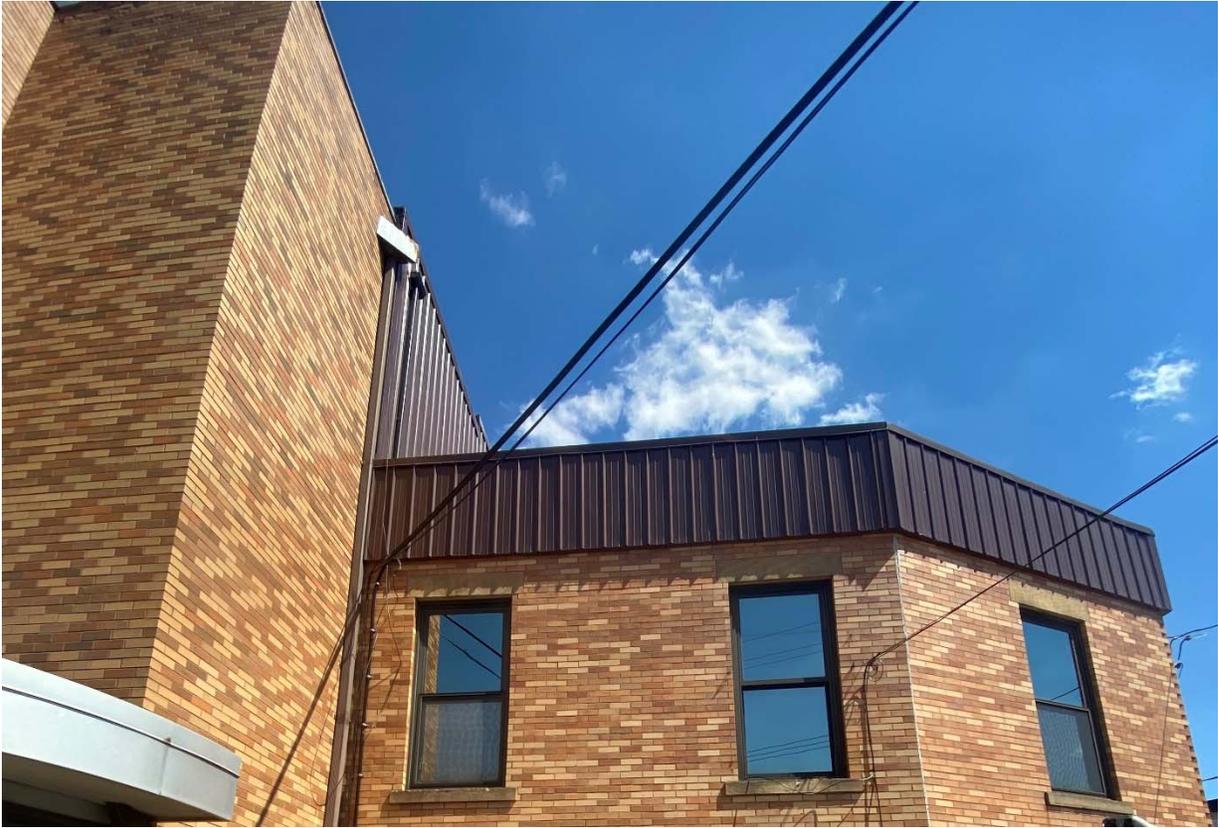
- In 1996 a final renovation was performed to provide for an elevator, and a new police station entrance.
- In 2019, the south end of the 1936 building addition suffered a bearing wall failure, which caused part of the roof to collapse onto the second floor. The existing 2nd floor framing was modified to become a near flat metal roof with a new wood enclosure wall and secure the remaining roof construction.

9 – COLLAPSED THIRD FLOOR LOCATION

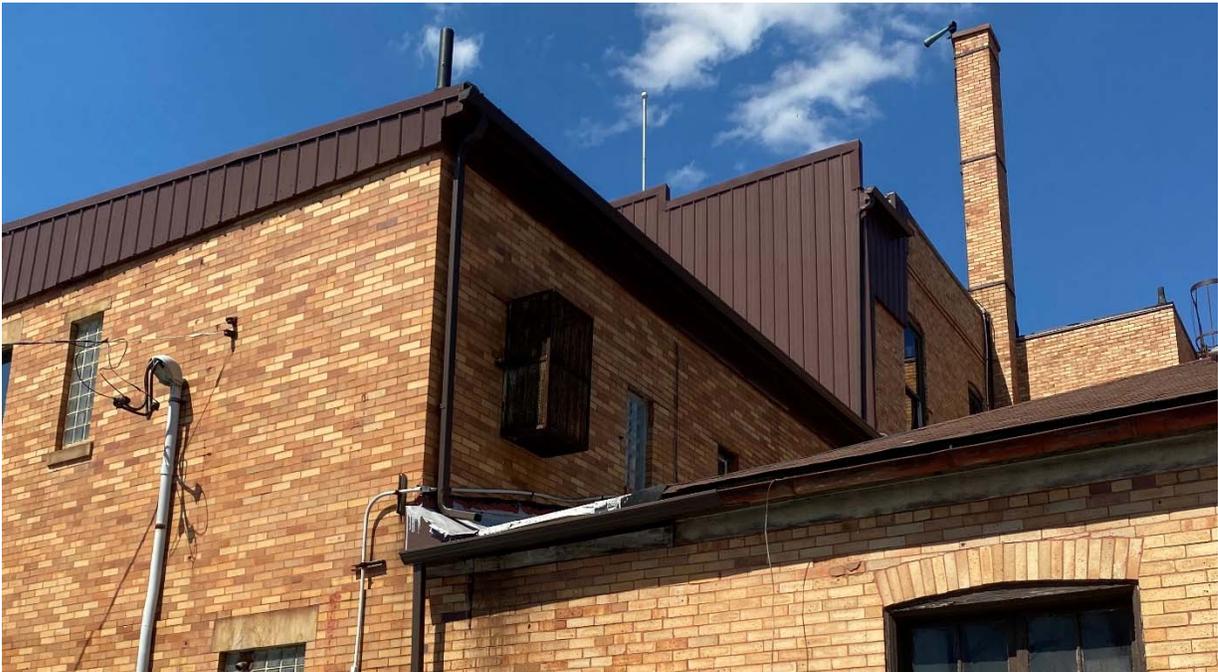
10 – COLLAPSED THIRD FLOOR LOCATION

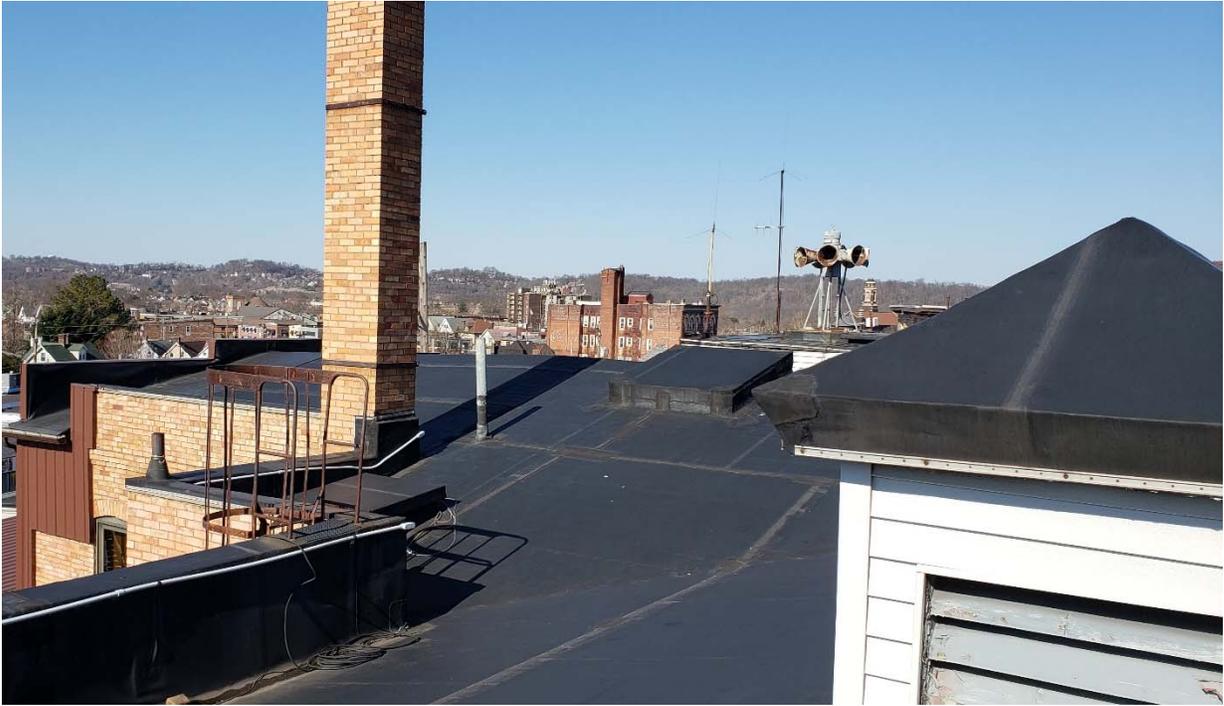
- The high roof of the 1906 building has an adhered EPDM membrane system that is out of warranty. The roofing system is well beyond the end of its serviceable life and is in need of full replacement. During inspection it was observed that there were open tears in the roof membrane system; it is our understanding that these roof leak locations have been temporarily repaired.

11 – TYPICAL HIGH ROOF (EPDM)

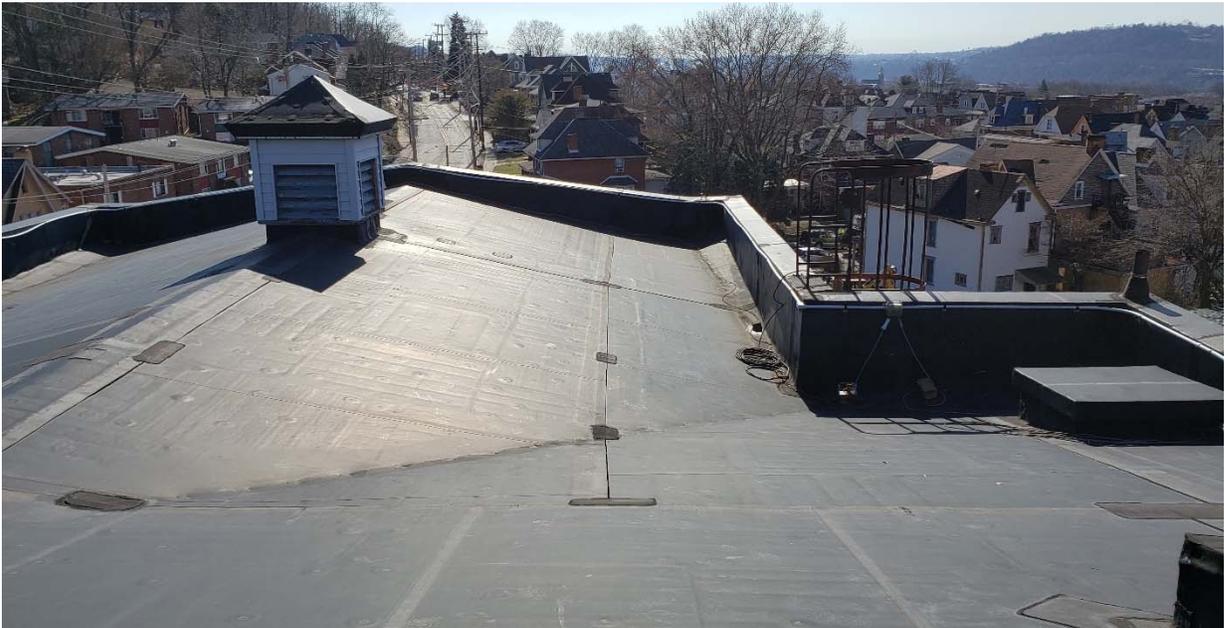
4 – TYPICAL HIGH ROOF (EPDM)

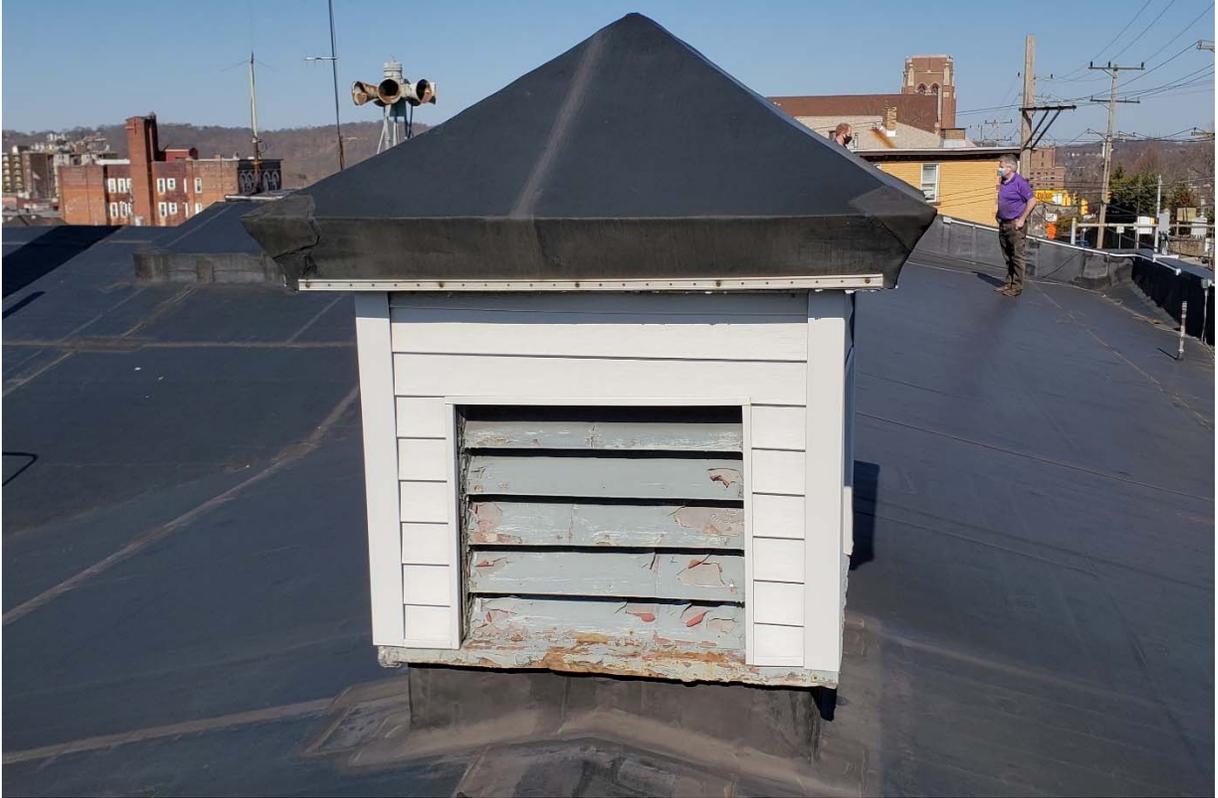
- The curbing and roof cap of what used to be the hose and/or bell tower is in disrepair and needs to be completely replaced.
 - The roof venting cupola is in disrepair and needs to be removed and/or replaced.

13 – ROOF VENT CUPOLA

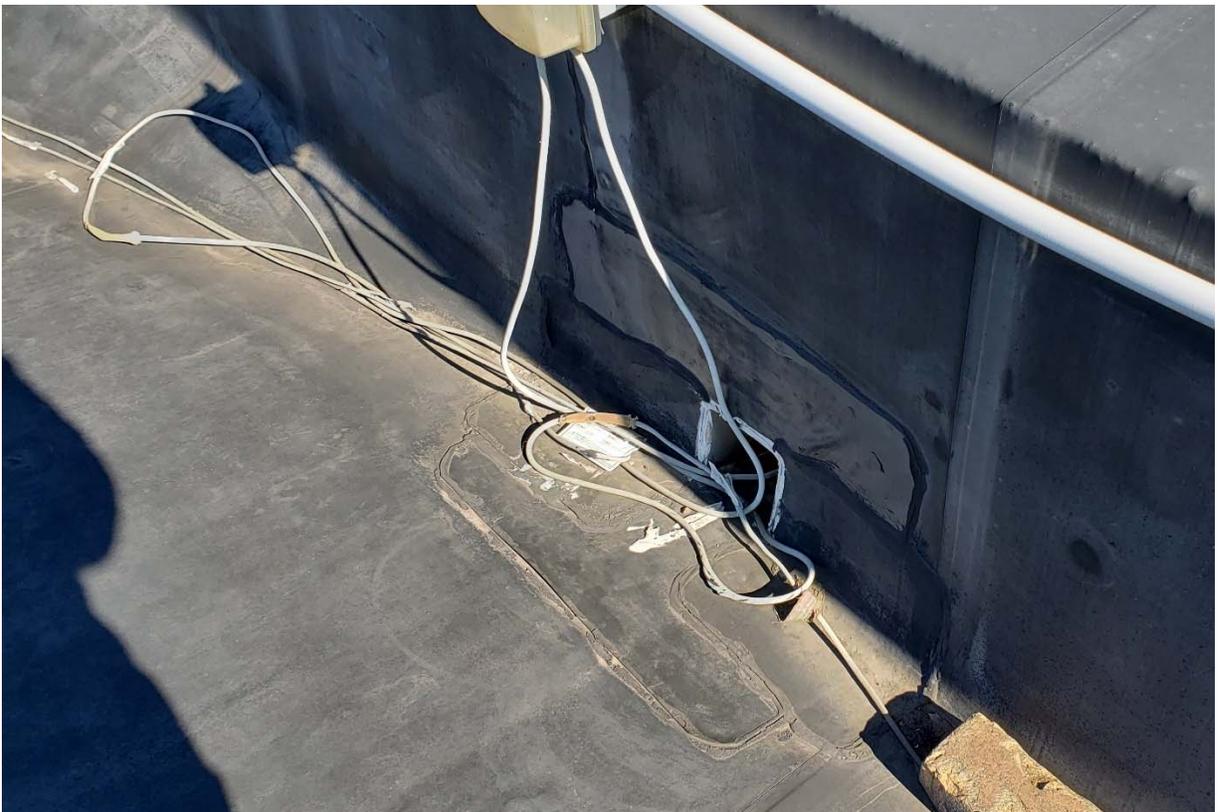
- The high roof is sloped to through wall scuppers that drain to exposed downspouts on the façade(s). The scuppers and downspouts are in fair condition. At some point in the past, electrical wiring was laid around the roof perimeter, in the valleys, and into the downspouts in an attempt to prevent winter ice build-up. The wiring is in disrepair and poses an electrocution and/or fire hazard. The existing heating wiring needs to be removed and/or replaced with a UL listed exterior heating wire system.

14 – DETERIORATED HEAT TRACE WIRES

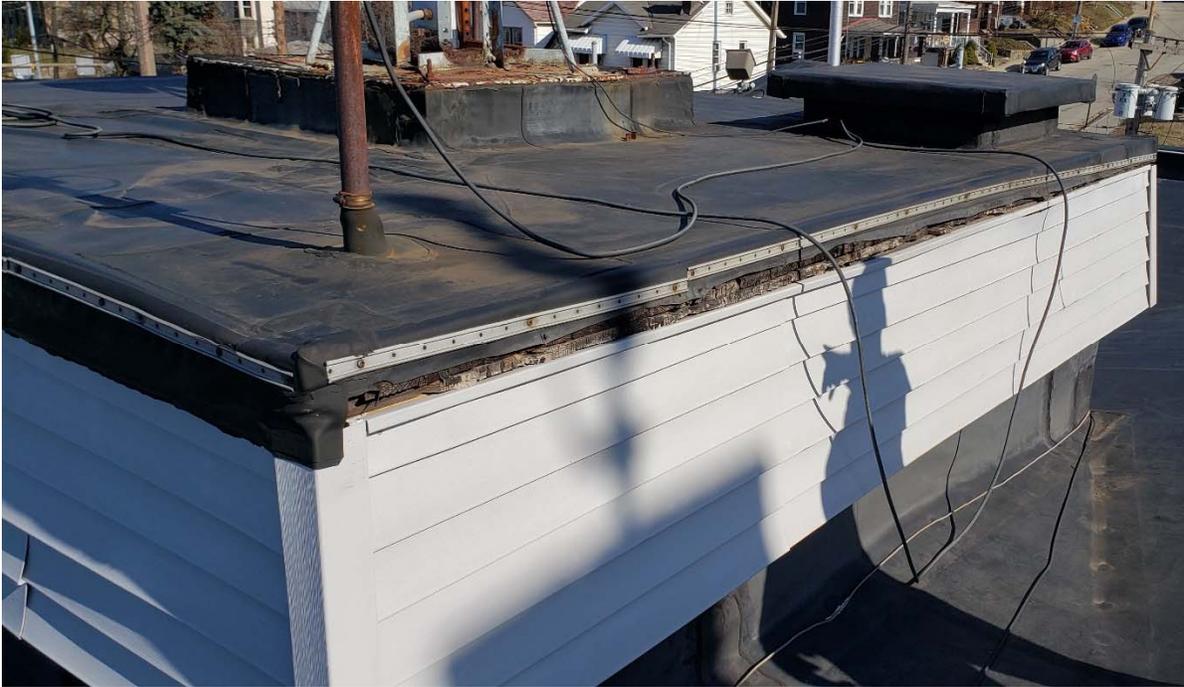
15 – HOSE/ BELL TOWER CAP

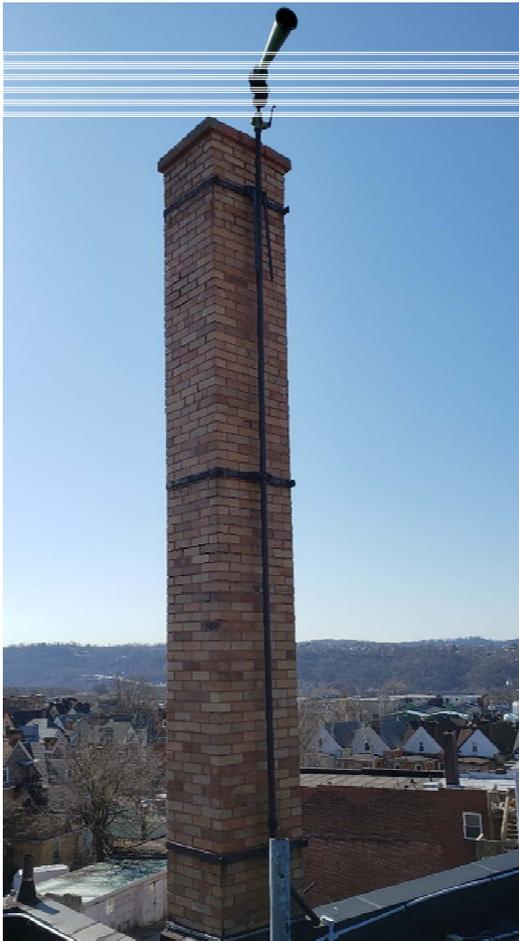
- The masonry chimney is in poor condition and needs to be repointed and recapped. Incinerating waste is illegal in Allegheny County, therefore there is no longer any reason to maintain the existing height of the chimney. It is recommended that the chimney be reduced in height by (+/-) two-thirds, and topped with a new precast capstone with pest screen cap.

16 – MASONRY CHIMNEY

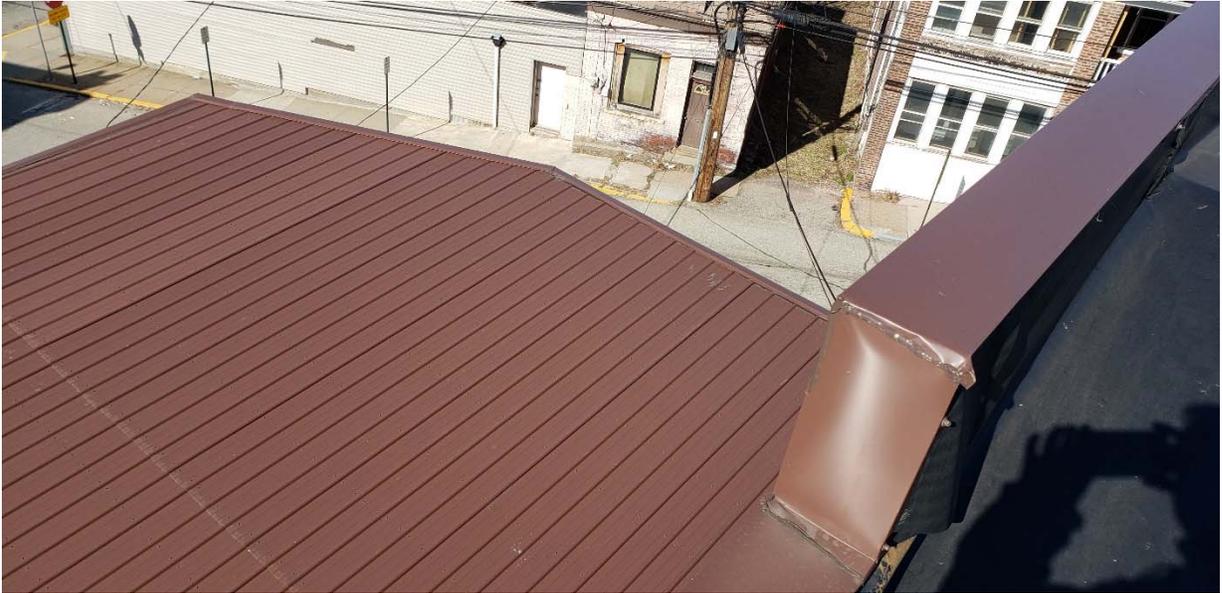
- The roof of the 1939 addition is a sloped metal roof that was installed on prefabricated wood trusses that rest on what was originally the second-floor structure; this roof was installed following the catastrophic collapse of the third-floor roof of the 1939 addition. The metal roof drains to exposed gutters and down spouts that are in fair to good condition.

17 – METAL ROOF AT THIRD FLOOR COLLAPSE

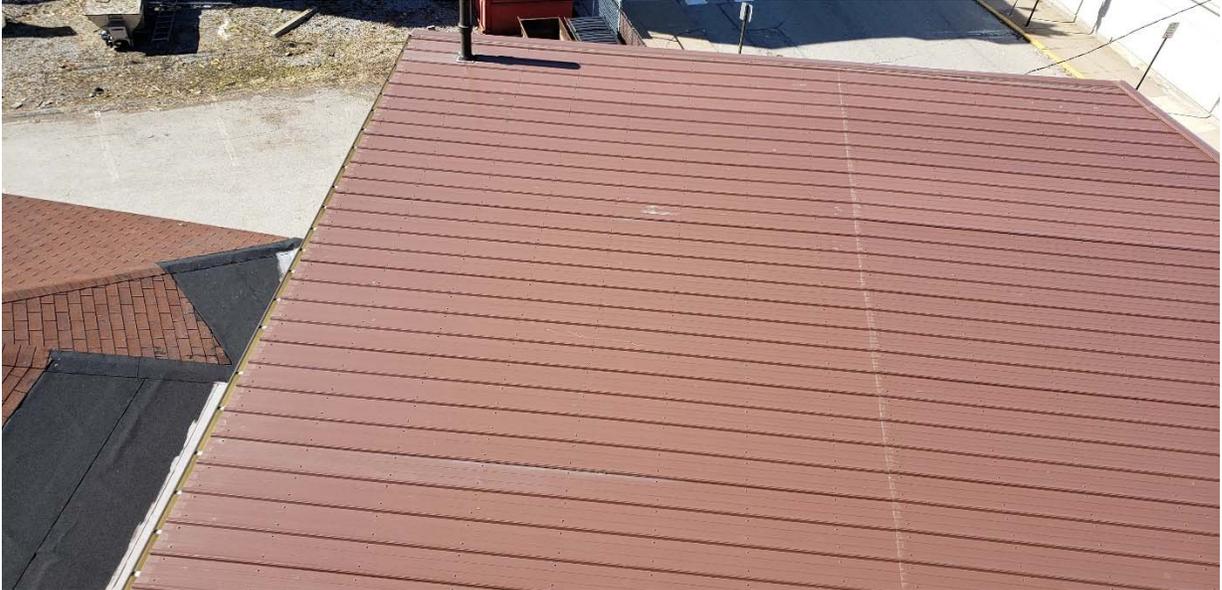
18 – METAL ROOF AT THIRD FLOOR COLLAPSE

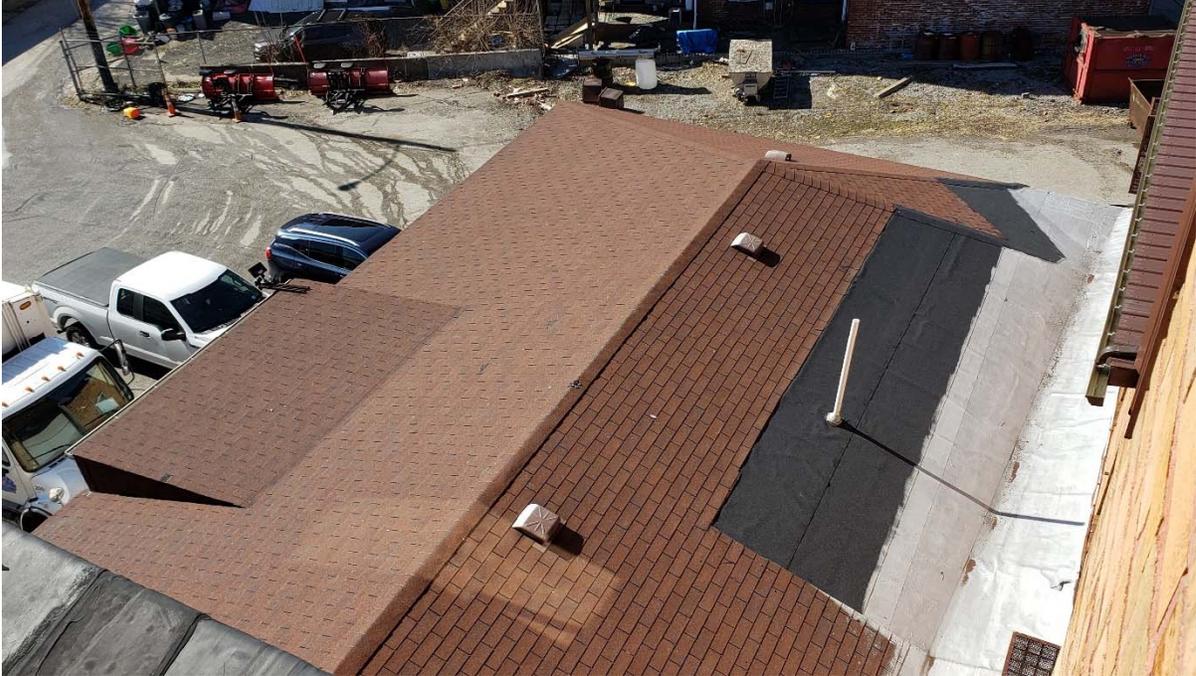
- The low roof on the circa 1950's garage is a combination of rolled asphalt and asphalt shingles. The roof is actively leaking throughout and needs to be replaced. The valley where the low roof meets the building should be re-framed to reduce drifting loads and improve drainage. The corresponding gutters and downspouts should be replaced during re-roofing.

19 – ASPHALT ROLL AND SHINGLE ROOF (MAINTENANCE GARAGE)

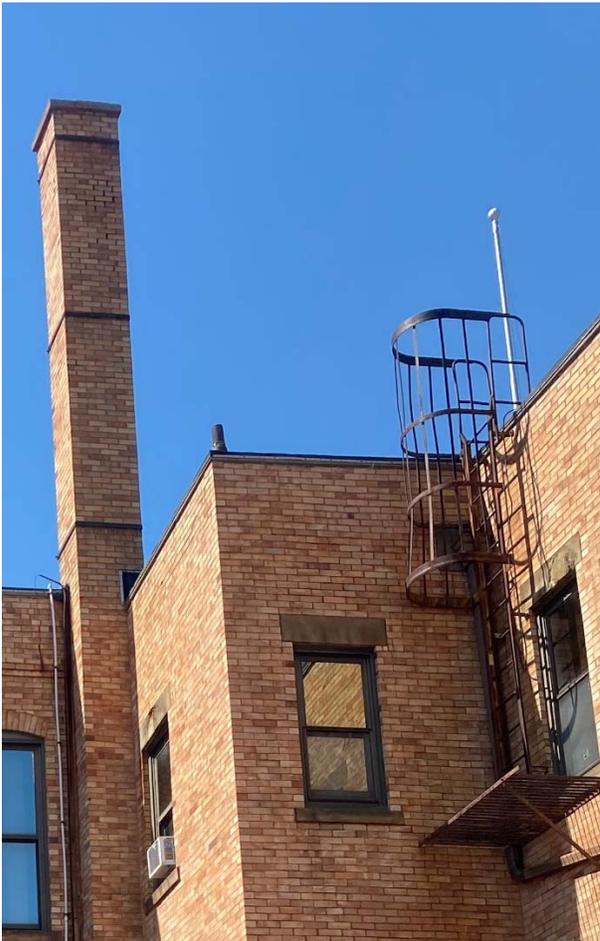
- The access to the high roof is via a second story window onto a shaky metal platform up an exterior metal ladder. The platform and access ladder does not meet OSHA standards and presents a fall and/or safety hazard. The platform is in disrepair; it does not have guard rails or fall protection; the ladder is in need of maintenance and repair. The roof access is an unsafe condition and should be immediately replaced.

20 -ROOF ACCESS PLATFORM AND LADDER

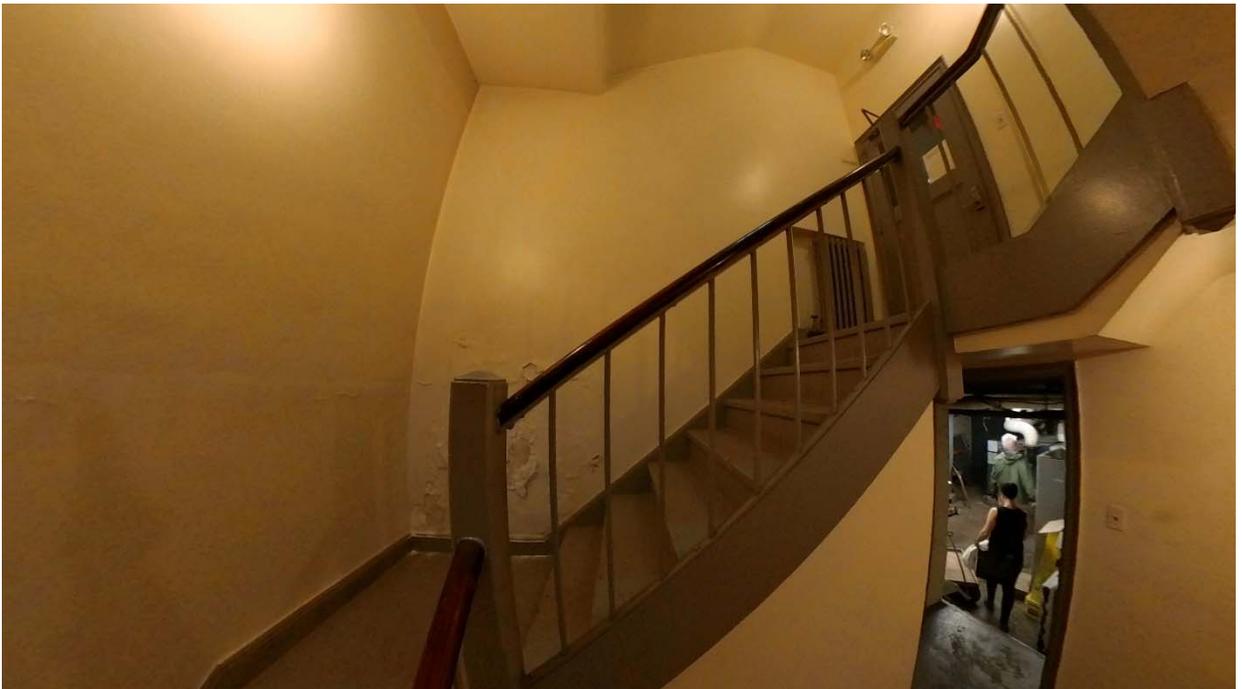
- **Emergency Means of Egress**
 - Existing Exit Stairways do not meet current Code requirements.
 - Existing Exit Stairways cannot be accessed without walking through adjoining or intervening spaces and/or areas.
 - Existing Exit “Corridors” do not meet current Code requirements.
 - There are no required Areas of Rescue.
 - The Main stairs do not meet the minimum the requirements for construction and/or condition.

22 – EMERGENCY STAIR

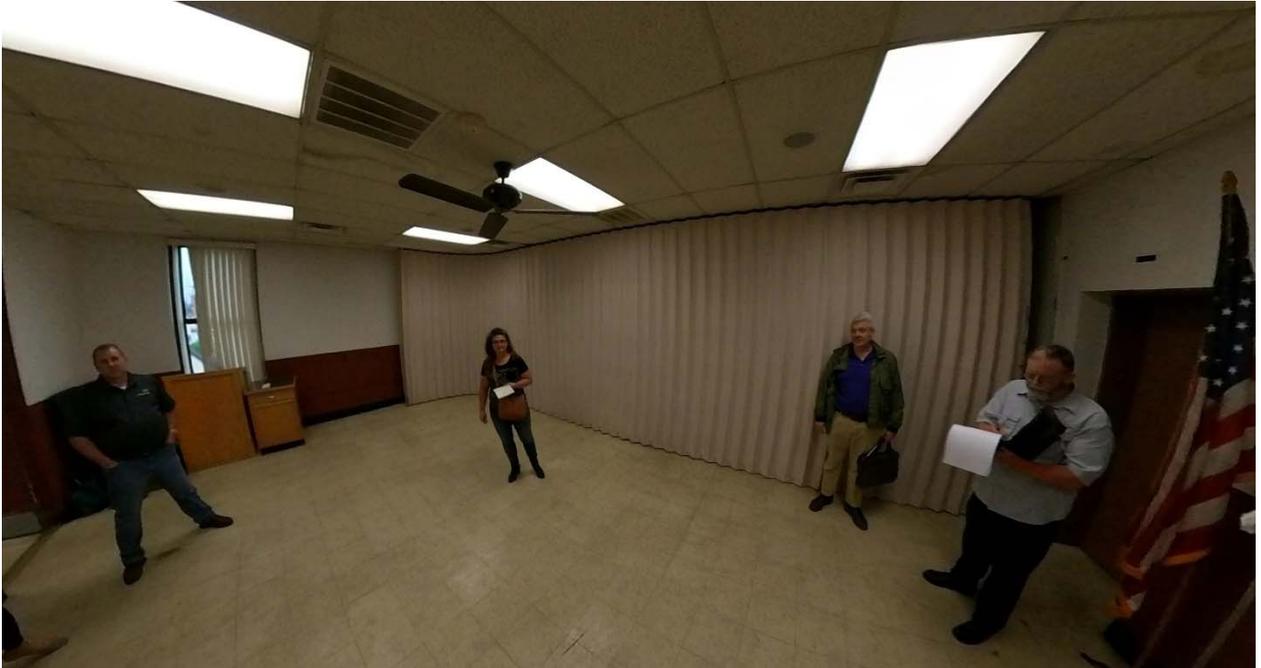
23 – COUNCIL CHAMBER (AFTER COLLAPSE)

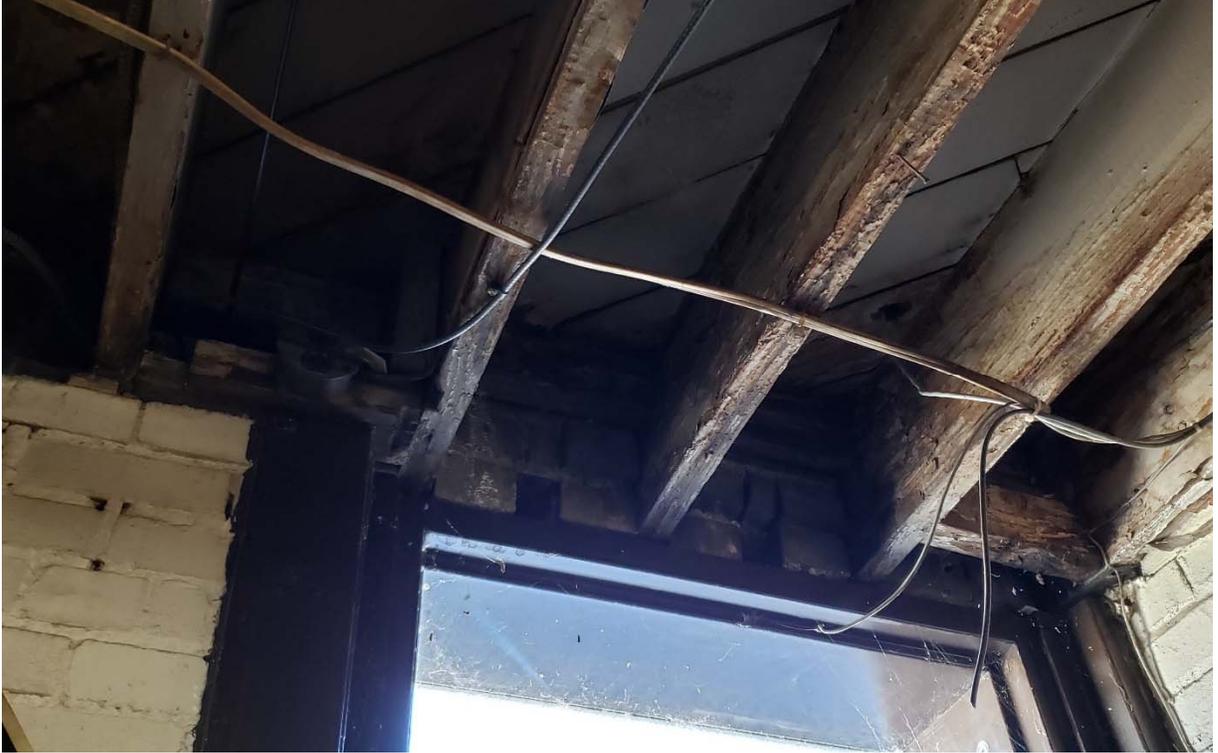
- Main Roof Structure Remarks: The roof framing is in fair shape. There has been areas of water intrusion and access to these areas would not allow physical inspection. The trusses bearings are in fair condition and the exterior walls are bonded to the attic and roof diaphragm with metal strapping.
- The roof joists were qualified to support a snow load with additional factors of safety required for an emergency services facility.
- Garage Roof Structure Remarks: The roof framing is in fair shape. The wall failure repair looks adequate. This roof was not assessed for loading or condition as it is exposed, and it is an unheated occupancy.

27 – EXPOSED STRUCTURE WITH WATER DAMAGE (TYPICAL)

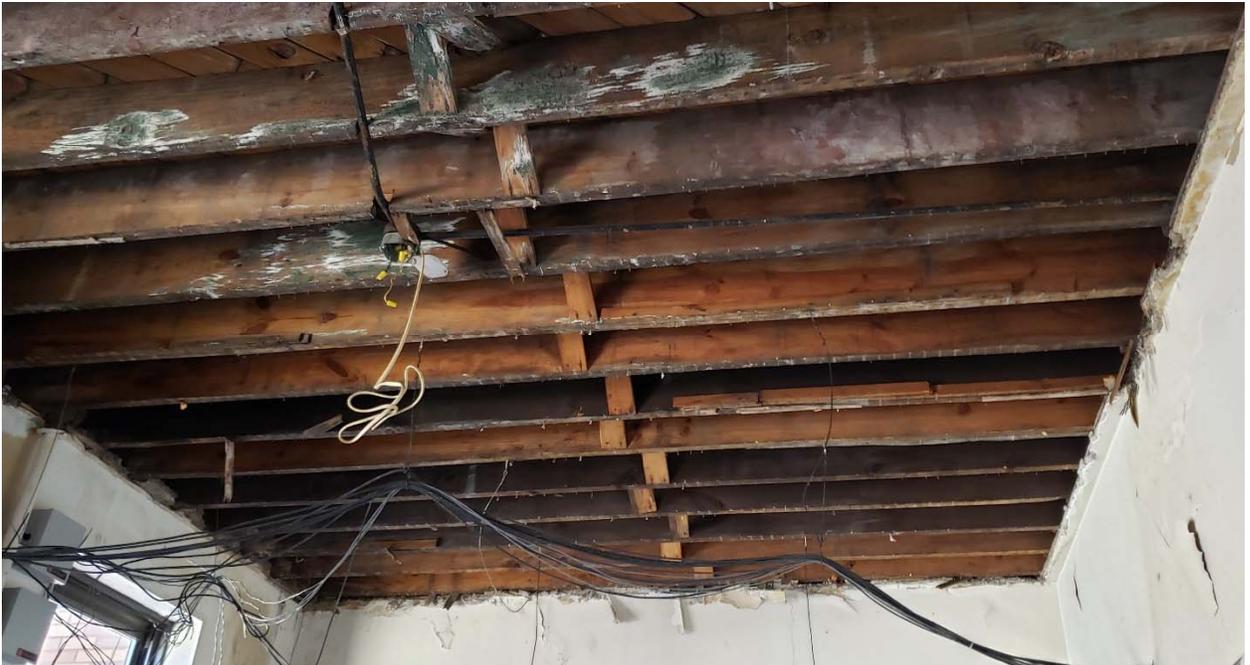
28 - EXPOSED STRUCTURE WITH WATER DAMAGE (TYPICAL)
